**DAM SAFETY INSPECTION REPORT
HOLLOWAY DAM
DAM ID 64
FLINT RIVER
GENESEE COUNTY – SECTION 11, T08N, R08E**

OWNER/OPERATOR: City of Flint
1101 South Saginaw Street, Suite N102
Flint, Michigan 48505

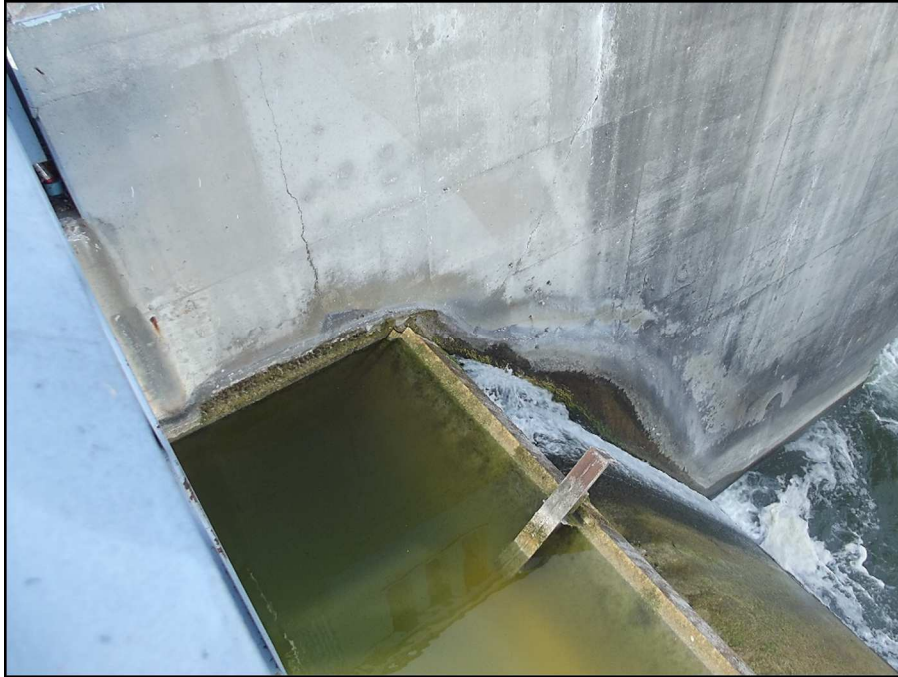
Photograph 23 – Leakage at left gate seal

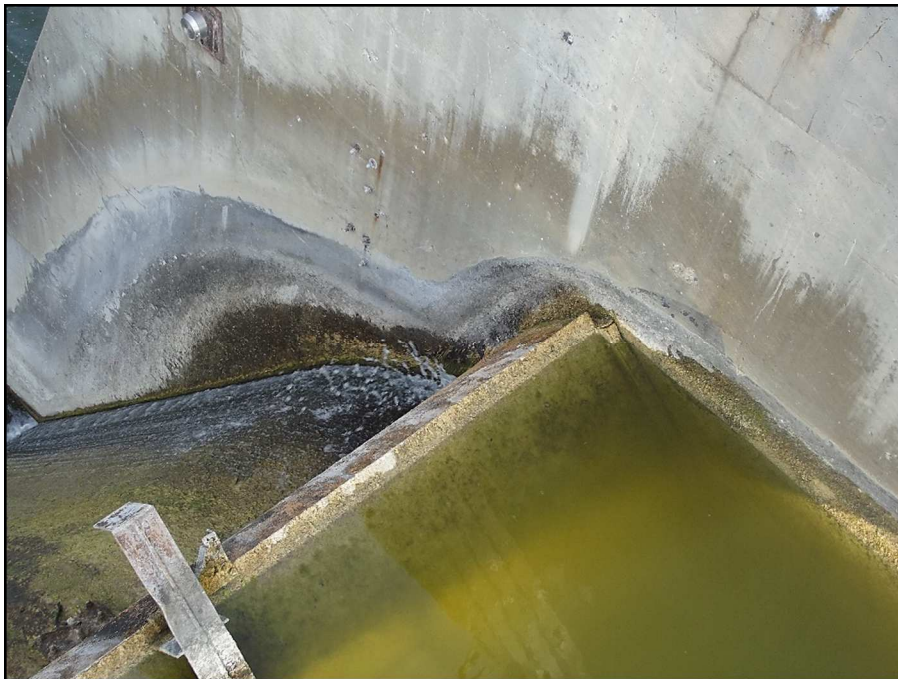
Photograph 24 – Leakage at right gate seal

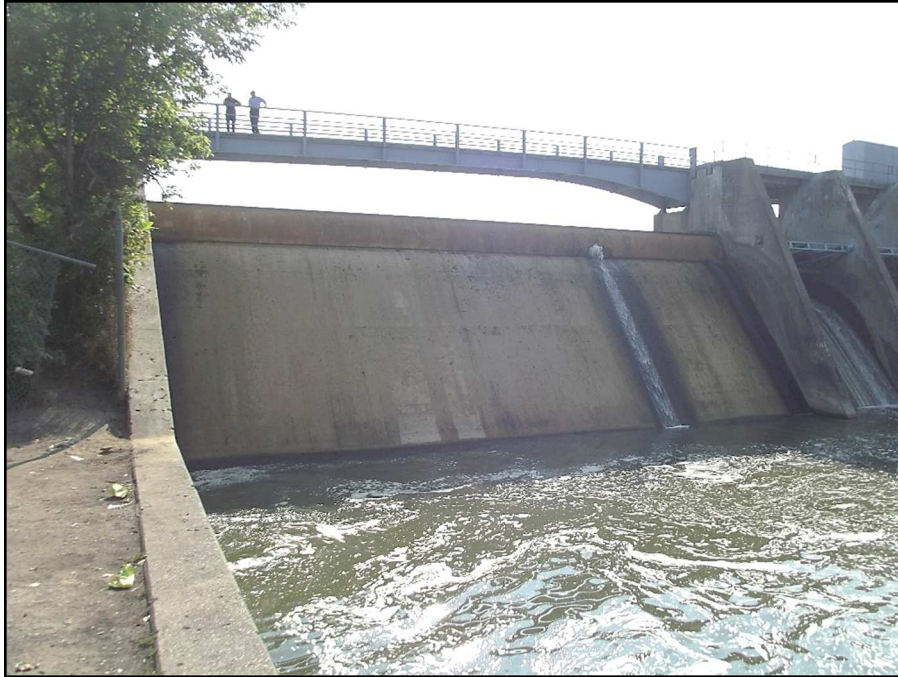
Photograph 25 – Right drum gate bay viewed from downstream

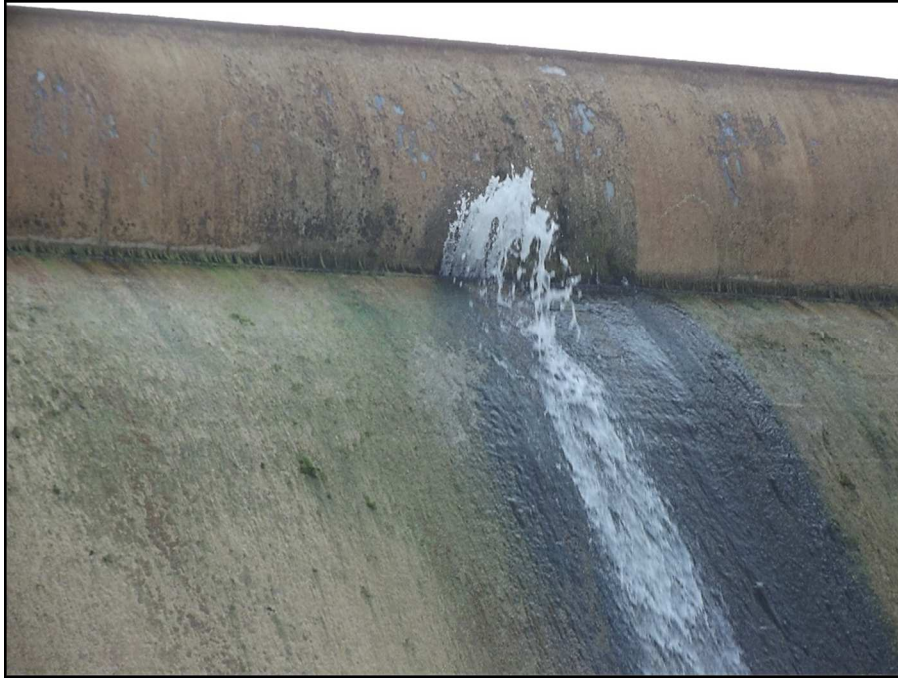
Photograph 27 – Leakage at base of drum gate

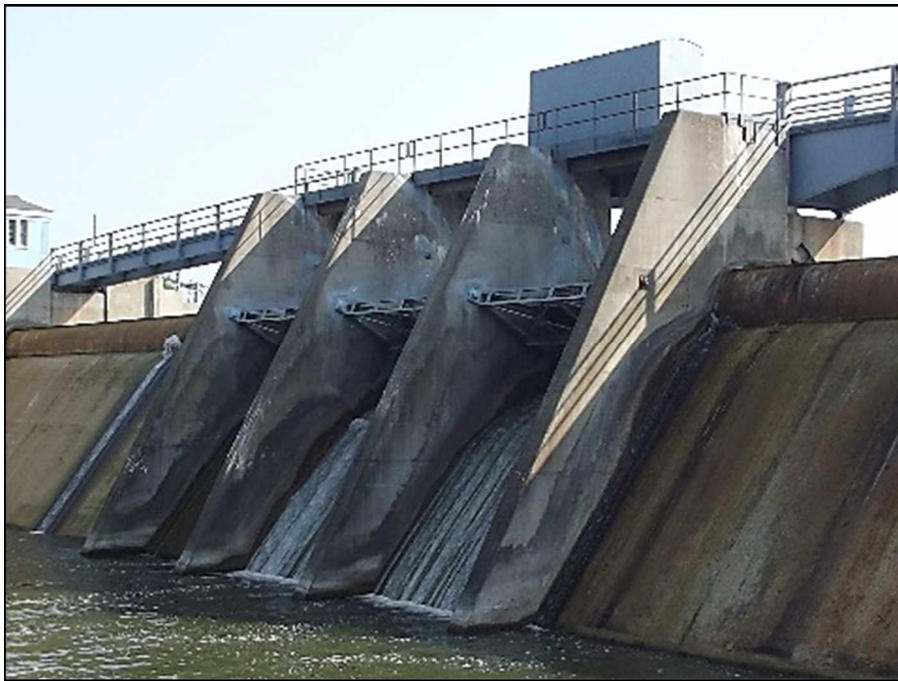
Photograph 28 – Three tainter gate bays viewed from downstream left

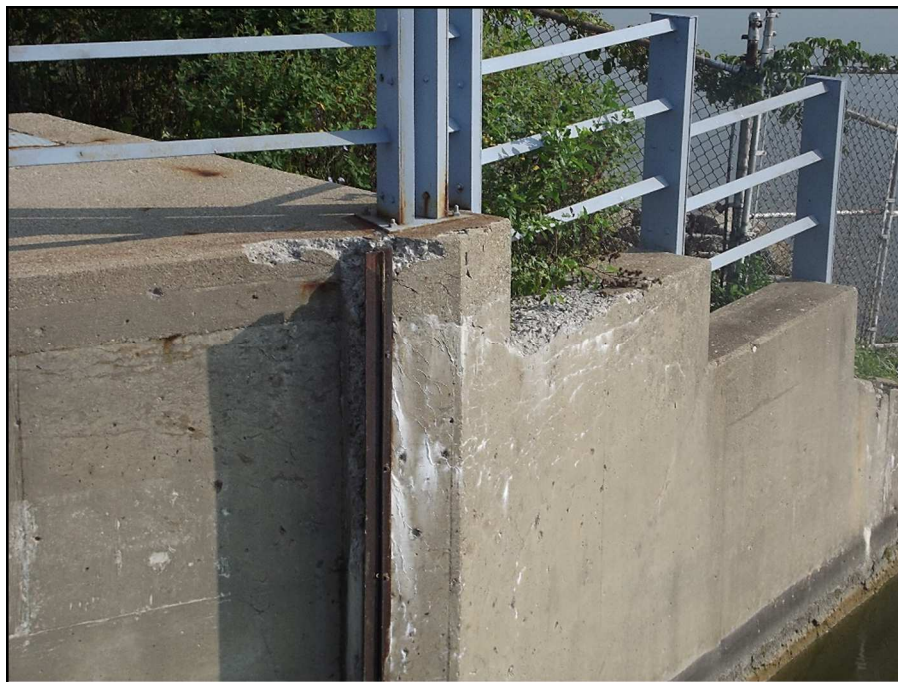
Photograph 36 – Spalling at top of wall

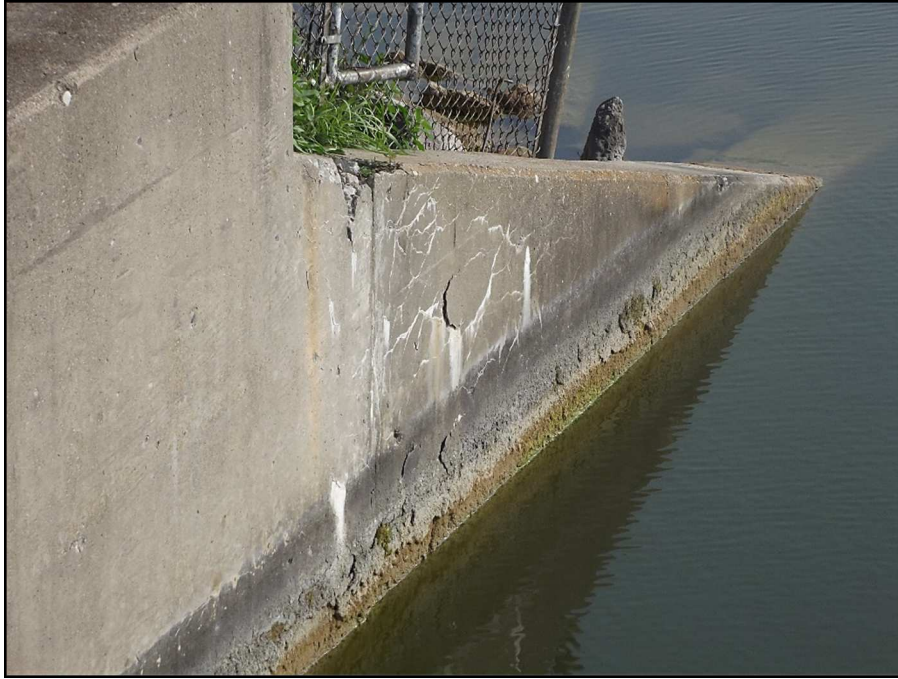
Photograph 37 – Spalling and delamination at upstream wing

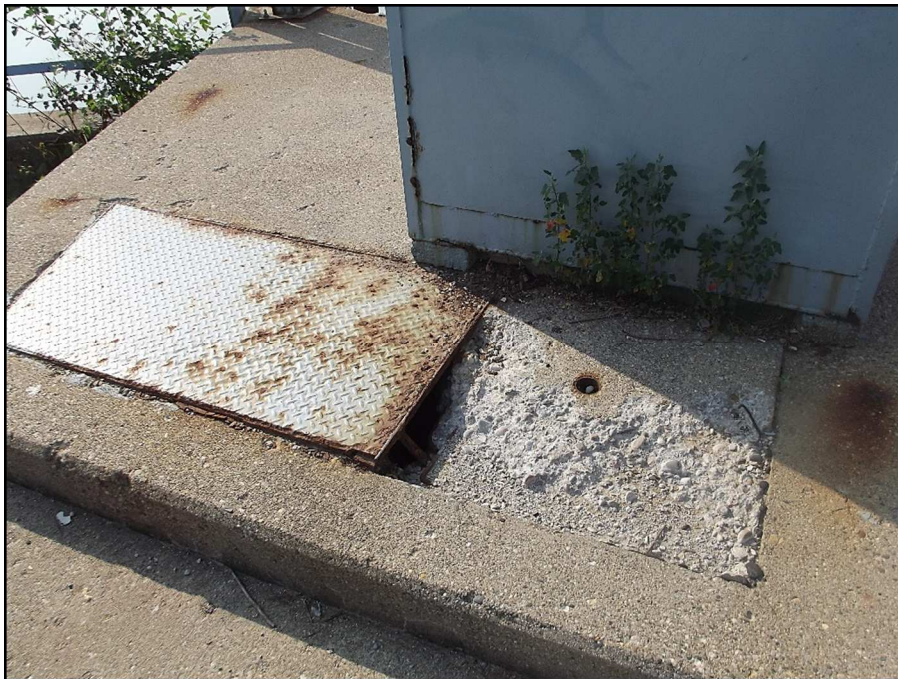
Photograph 38 – Spalling at right abutment near drawdown gate operator

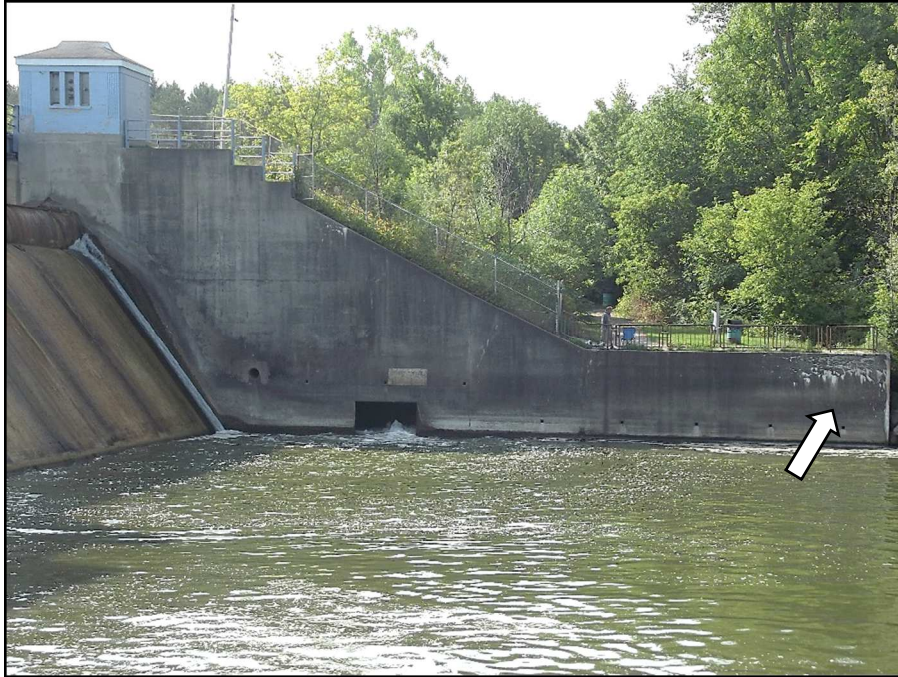
**Photograph 39 – Left downstream abutment wall
Note: minor efflorescence**
